Contract #: 04-0120F4Cty: SF/ALA Rte: 80 PM: 13.2/13.9File #: 13.28**WELDING INSPECTION REPORT****Resident Engineer:**Pursell, Gary**Address:** 333 Burma Road**City:** Oakland, CA 94607**Report No:** WIR-007753**Date Inspected:** 10-Jul-2009**Project Name:** SAS Superstructure**OSM Arrival Time:** 900**Prime Contractor:** American Bridge/Fluor Enterprises, a JV**OSM Departure Time:** 1530**Contractor:** Oregon Iron Works Clackamas, Or.**Location:** Clackamas, OR**CWI Name:** Steve Barnett**CWI Present:** Yes No**Inspected CWI report:** Yes No N/A**Rod Oven in Use:** Yes No N/A**Electrode to specification:** Yes No N/A**Weld Procedures Followed:** Yes No N/A**Qualified Welders:** Yes No N/A**Verified Joint Fit-up:** Yes No N/A**Approved Drawings:** Yes No N/A**Approved WPS:** Yes No N/A**Delayed / Cancelled:** Yes No N/A**Bridge No:** 34-0006**Component:** Hinge-K Components**Summary of Items Observed:**

Summary of Items Observed: On this date, Caltrans Quality Assurance Inspector (QA) Clete Henke was present at Oregon Iron Works, Inc. (OIW) in Clackamas, OR for observation of fabrication of the Hinge K Pipe Beams and related activities including in process welding and OIW Quality

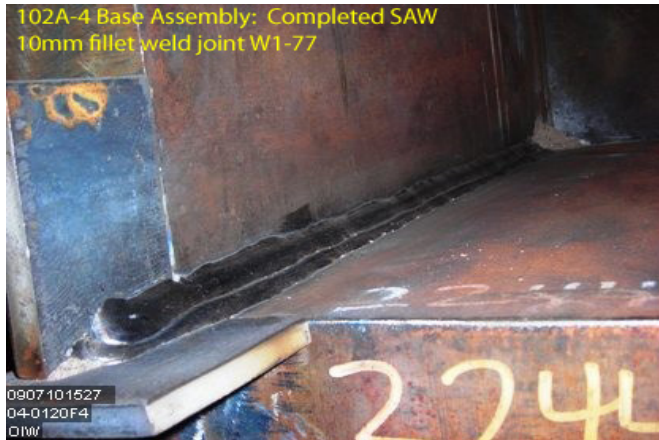
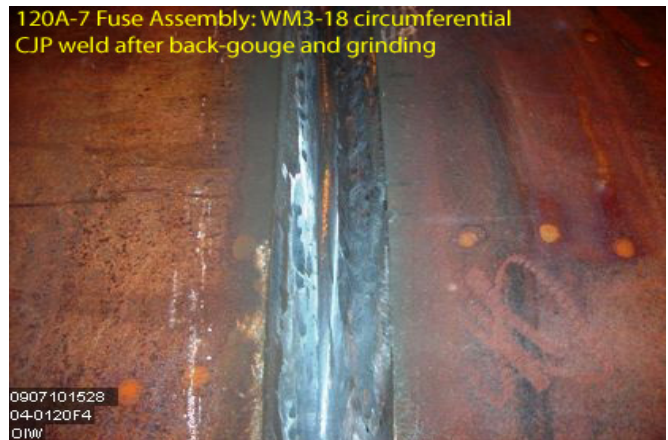
The QA Inspector performed 100% Visual Inspection (VT) and 10% Magnetic Particle Testing (MT) verification at completed Partial Joint Penetration (PJP) weld joints designated WM3-12, WM3-13, WM3-14, WM3-15, WM3-16 & WM3-17. The referenced connections join a125 stiffener rings with a124-8 fuse section. After VT and MT verification, the QA Inspector determined that the connections noted above appeared to be in general compliance with the contract requirements. Please reference TL-6028 report for this date for further details.

The QA Inspector noted upon arrival that Inside Diameter (ID) side of circumferential weld joint WM3-18 had been completed and back-gouged from the outside. OIW welder John Tellone (WID T23) was observed grinding the back-gouged location in an attempt to achieve a weldable profile in preparation for initiation of the Outside Diameter (OD) side of the Complete Joint Penetration (CJP) weld. Welder T23 was engaged in the activity described above for the duration of the day shift. At the onset of swing shift, OIW welder Bounheune Savahn (WID S74) was observed continuing grinding and was still engaged with this activity at 1530 hrs when the QA Inspector departed.

The QA Inspector intermittently observed OIW welder Rick Hinkle (WID H49) during in-process tack welding at multiple stiffeners on the base assembly 102A-1. Tack welding was performed utilizing Flux Cored Arc Welding (FCAW) in the vertical (3F) position in accordance with approved. Tack welding at the locations referenced above appeared to be in general compliance with approved contract documents.

The QA Inspector intermittently monitored OIW welders Tim O'Brien (WID O6) on day shift and Bui Liem (WID B10) on swing shift during in progress Submerged Arc Welding (SAW) at weld joints W1-61, W1-57 & W1-53(O6) and W1-49(B10). The referenced connections join a107 and b106 stiffeners. The QA Inspector intermittently observed as welders T23 & B10 deposited SAW passes in the horizontal (2F) position in accordance with approved welding procedure. The QA Inspector noted the OIW welders were maintaining continuous preheat utilizing a torch. Referenced connections W1-61, W1-57 & W1-53 were completed during the day shift and W1-49 was in-process at 1530 hrs when the QA Inspector departed. The QA Inspector observed OIW QC Inspectors Jose Salazar and Steve Barnett regularly monitoring and recording the in process SAW parameters during day and swing shift respectively. The QA Inspector also intermittently observed in process welding parameters and determined that the SAW parameters and minimum preheat/interpass temperature appeared to be in general compliance with the contract requirements -- (W1-57: 35 volts, 585 amperes, 508mm/min travel speed).
